NATIONAL FIRE INVESTIGATOR

Summer
2017

FIRE RISKS DUE TO UNINTENTIONALLY ENERGIZED METAL STRUCTURES

ABSTRACT

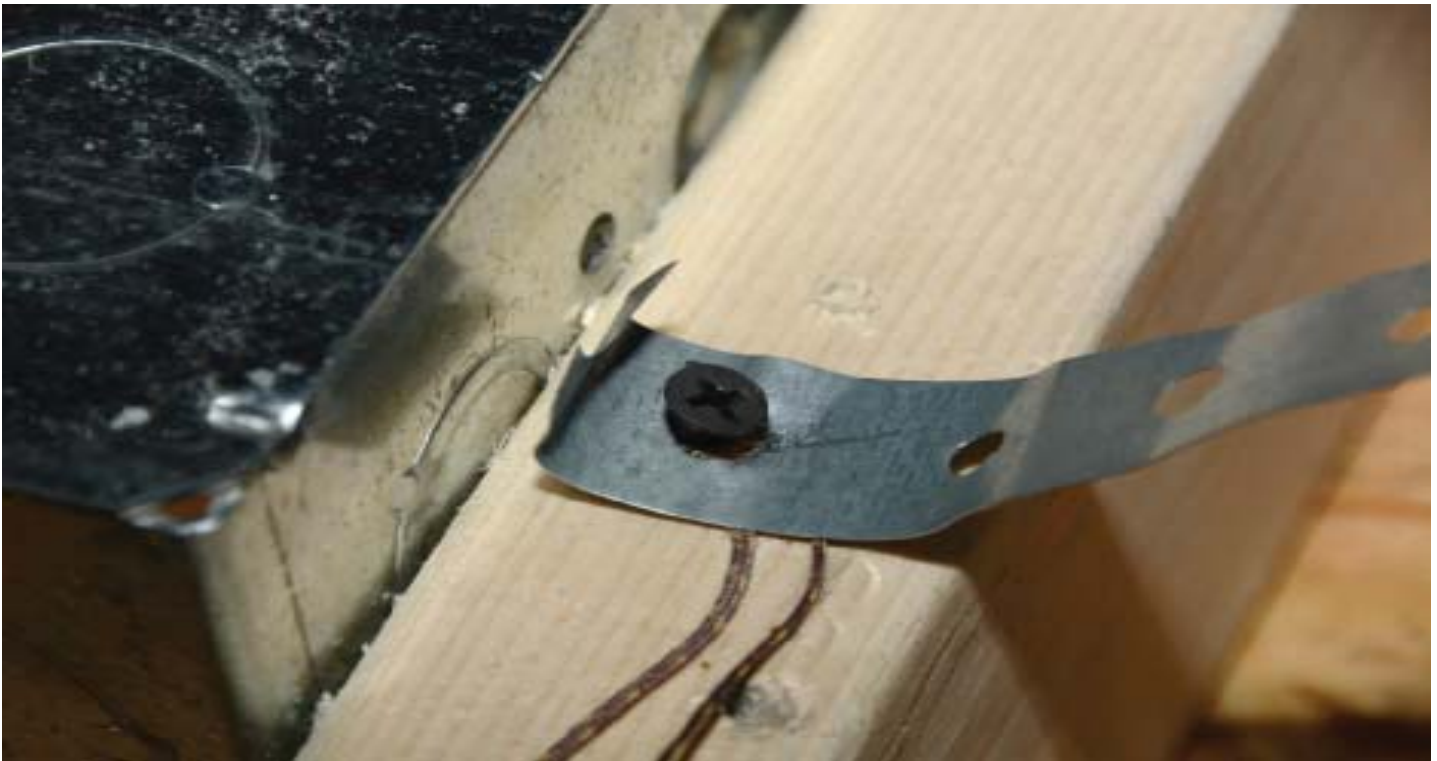
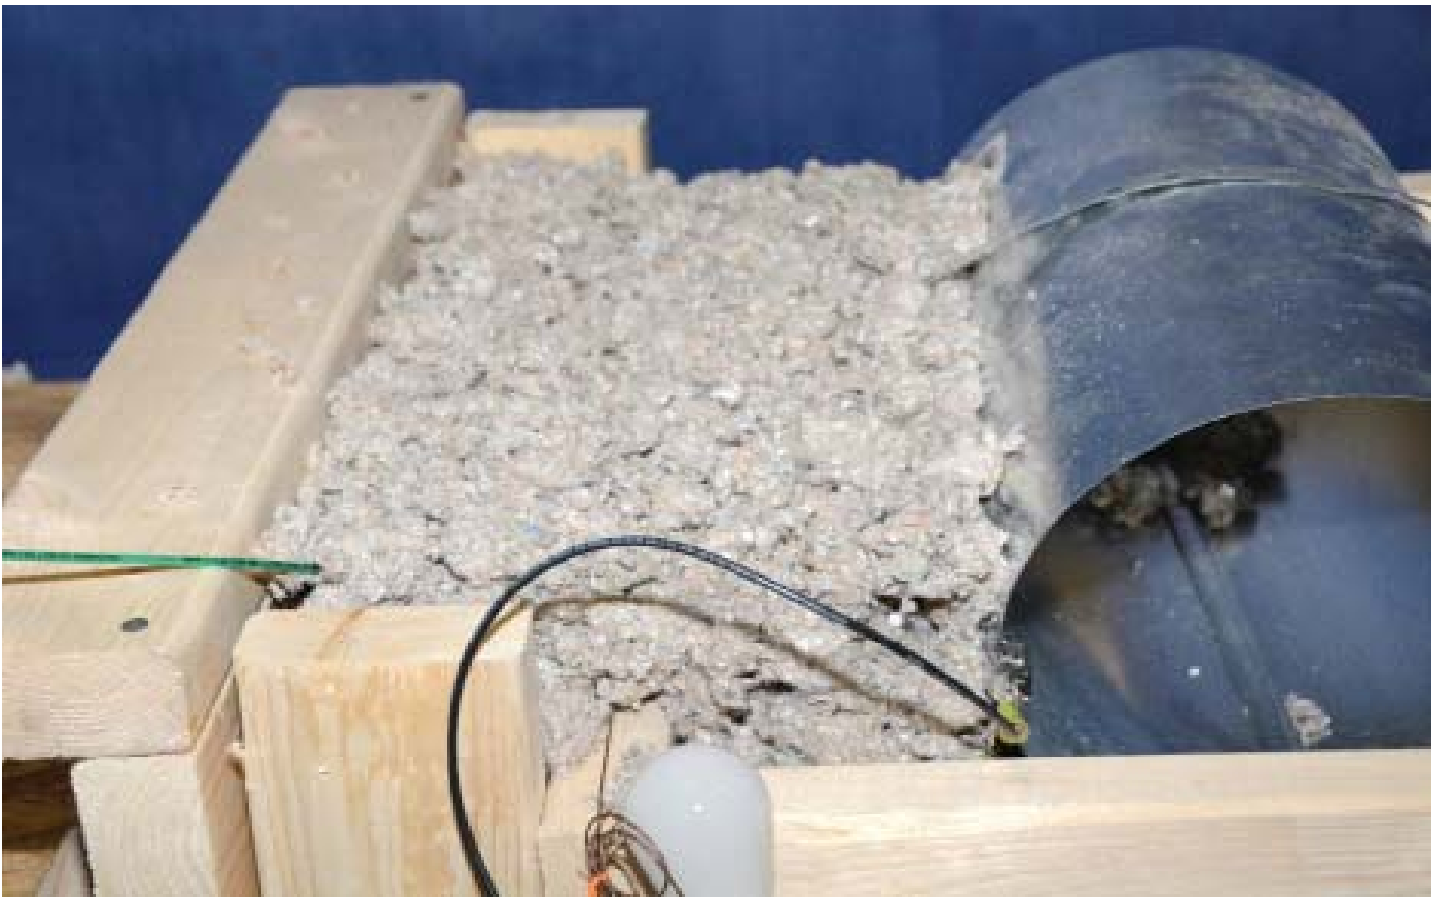
Figure 4 – Photographs of the Energized Duct / Grounded J-box test setup showing the connections between the metal strapping, screw, and J-box (top) and the setup after addition of the cellulose insulation (bottom).

In these tests, a small assembly was fabricated to represent a joist space that is common in an attic or basement setting. In this space an HVAC duct was secured using metal strapping that was attached to 2" x 4" wooden members using 2" drywall screws. The screws passed through the wood, and contacted a grounded junction box. Six inches of cellulosic insulation was then added to the setup to represent a typical insulated joist space.

A circuit diagram showing the electrical setup for the test system can be seen in Figure 3. Photographs of the setup can be seen in Figure 4.

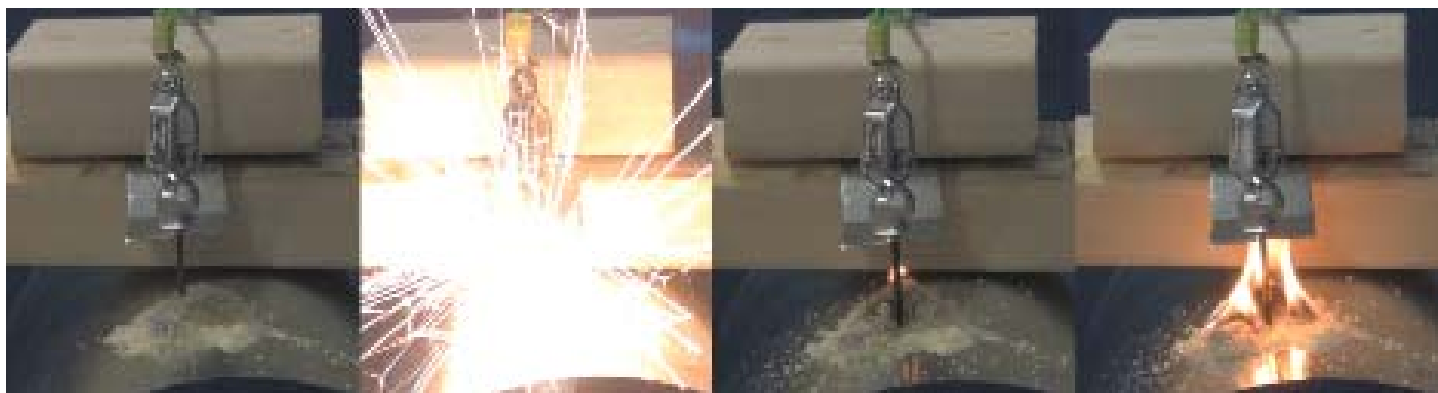
Figure 5 – Still images taken during Test Number 1 with no added resistance and no grounding of the HVAC duct.

In the tests performed with no alternate path and no added resistance, the ejection of molten metal was observed when the circuit was energized and the 20-amp breaker tripped quickly enough that the lightbulb in the circuit never appeared to turn on. In 2 of the 5 tests with no alternate path and no added resistance, the ejected molten metal ignited the fuel package causing flaming combustion that continued until the fuel package was consumed. Figure 5 shows still images of the metal ejection and subsequent ignition observed during testing.

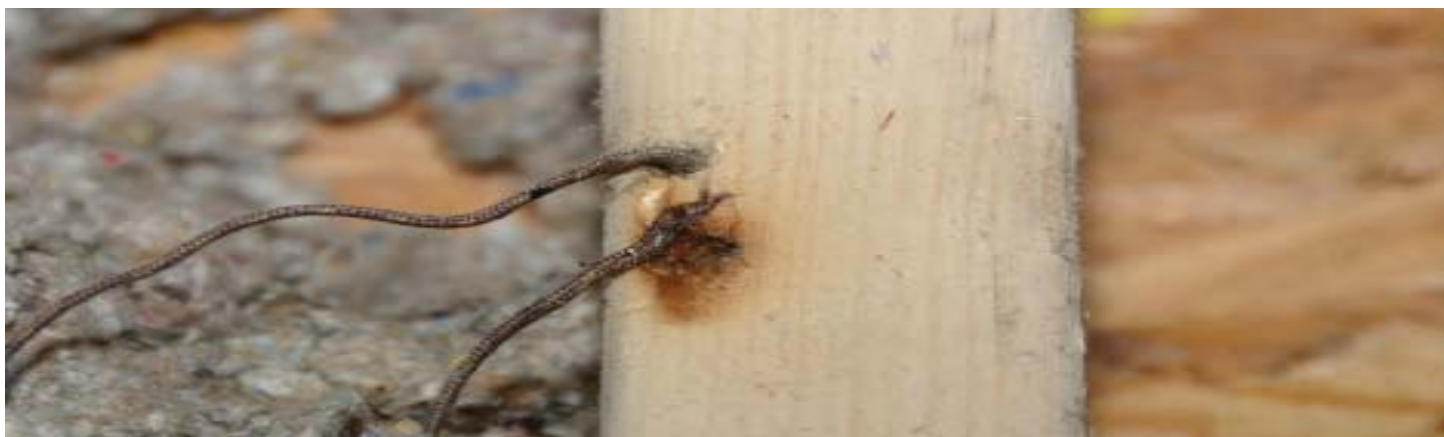
Figure 9 – Photograph of thermal damage to the wood around the screw head taken after the end of the first test.

In both tests of this type, significant heating at the connection between the metal strapping and the screw was observed. In the first test, the heating lasted 80 minutes but ceased when the connection between the screw and the junction box was lost. In the second test, the connection was intentionally interrupted after 6 hours.

After each test, the cellulosic insulation around the connections between the duct and the grounded junction box was removed to allow for examination of any hot spots. Photographs of the observed thermal damage can be seen for the first and second test in Figure 9 and Figure 10, respectively.

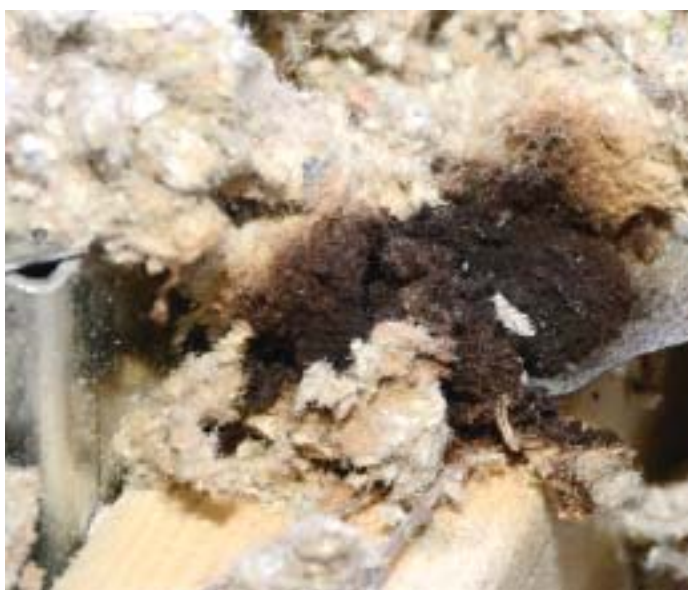
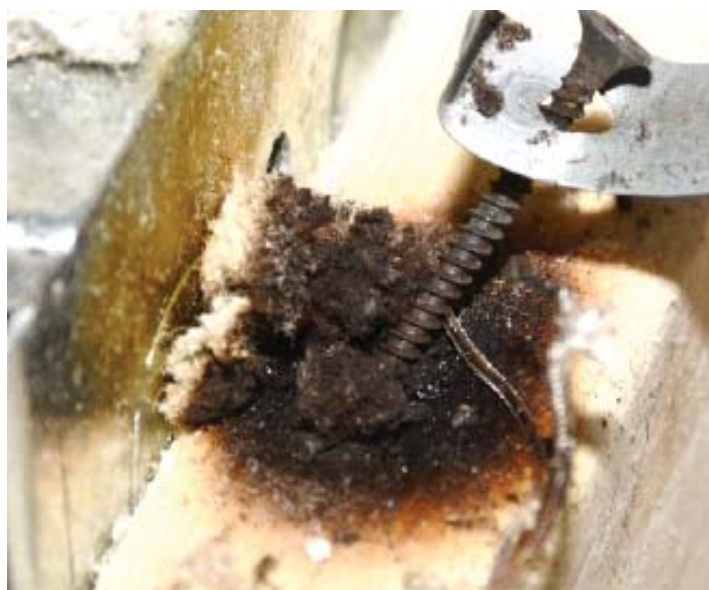
Figure 10 – Photograph of the thermal damage, evidence of combustion, and consumption of the wood and cellulosic insulation taken after the end of the second test.

In the second test setup, the heat generated at the contact between the strapping and the screw generated sufficient heat over only six hours to consume parts of the wooden 2" x 4" and the cellulosic insulation. Had this heating been allowed to continue over time (days, weeks, or months) in a full home environment, significantly more damage could occur. The energy release rates of the strapping-to-screw contact did appear to be increasing over time based on the increase in voltage across the connection and the slow rise in temperature over time. Temperature accelerated corrosion could further increase the resistance of such connections, which may increase the heat release rate over time.
